PUMPCOAT

CASE HISTORY 004 - REFURBISHMENT OF SALT WATER PUMP IMPELLERS, CASES & BASES

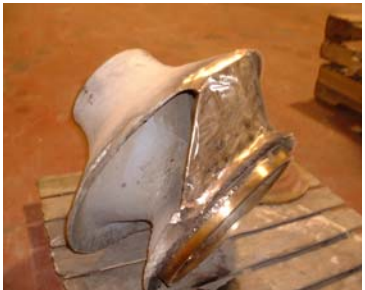
Power plant in New England needed to replace four bronze salt water impellers. New impellers were a 4 month lead time.

Pump impellers had run for 12 years with extensive vane wear.

Pumpcoat repair welded, epoxy coated and balanced the impellers.

Worn out casings were also refurbished by epoxy rebuild with Aluminum oxide filled epoxy.

Additional rebuild of the pump bases included welding, fabrication of new pump support feet and epoxy coating of the entire baseplate.
