PUMPCOAT

CASE HISTORY 012 - BOILER FEED PUMP

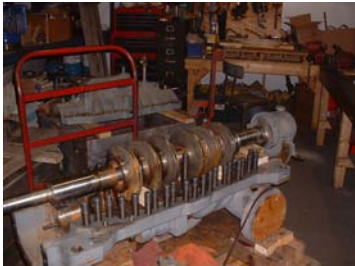
Industrial power plant in the northeast was experiencing premature wear of steel casing.

Customer experienced washout of casing at area behind throttle bushing and center bushing.

Pumpcoat provided casing repair and modification of throttle bushing and center Bushing by adding AFLAS O-Rings.
