PUMPCOAT

CASE HISTORY 015 - BLOW DOWN TANK REPAIR

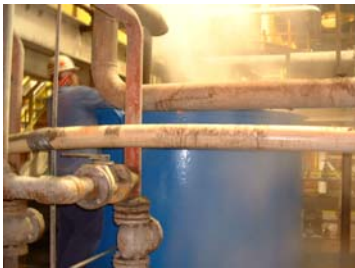
Blow down tank had excessive pitting

Customer scheduled repair and coating of blow down tank. After grit blast , tank bottom was found to have excessive pitting and pin holes.

Pumpcoat provided material and a service supervisor to work with the customers personnel

to install a reinforced epoxy liner during the customer outage.
