# PUMPCOAT

### CASE HISTORY 027 - CONDENSER WATER BOX REPAIR

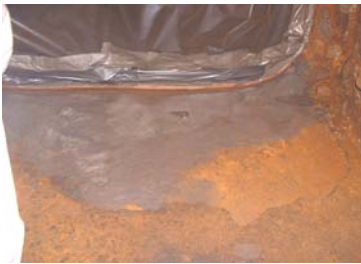
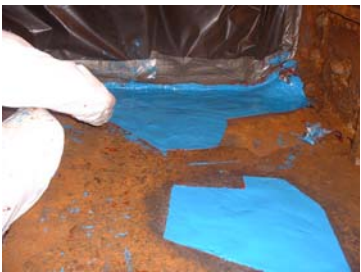
Customer had hole in condenser water box.

Corrosion weakened the metal and customer needle-gunned a hole in condenser water box.

Pumpcoat coating technician repaired hole by grit blasting, applying paste grade epoxy to fill the corroded area, and then a top coat to seal and waterproof. Patch was reinforced with polyester cloth. Patch has been working for 5 years.
