PUMPCOAT

CASE HISTORY 028 - LARGE SHAFT & IMPELLER REPAIR

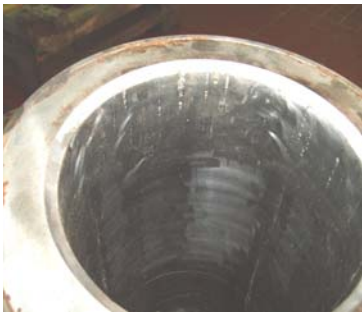
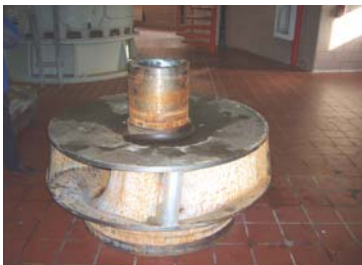
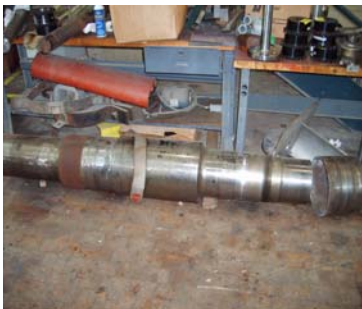
Regional Water Authority had a large bore 42 in. impeller and 6 ft. shaft that needed repair.

Impeller & shaft had severe galling.

Pumpcoat arranged transportation to our affiliate machine shop where galled areas of impeller were welded and bored to restore damaged areas. Additional machine work done to the Ring, Arbor & retaining nut and then impeller was dynamically balanced.

On the shaft, the galled areas were welded, and it was undercut true and concentric. Then it was chrome plated and finished. Both pieces were transported back to customer.
