### CASE HISTORY 003 -

ABRASIVE RESISTANT EPOXY USED TO INCREASE  
PARTS LIFE

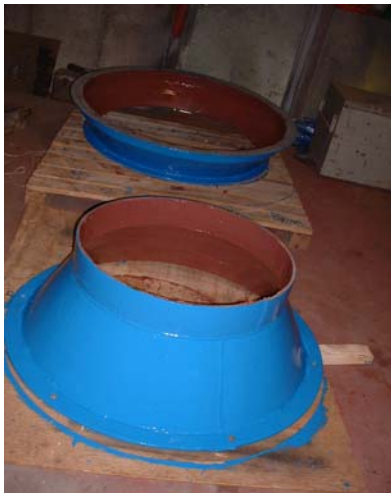
Power plant in New England needed to increase coal pulverizer parts wear resistance.

Plant maintenance people replaced classifier cones on a regular basis.

Pumpcoat coated new classifier cones with thick film abrasive resistant epoxy. Worn out parts were also refurbished by welding patches and rebuild with Aluminum oxide filled epoxy.
