PUMPCOAT

CASE HISTORY 031 - HEAT EXCHANGER DIVISION PLATE COATING

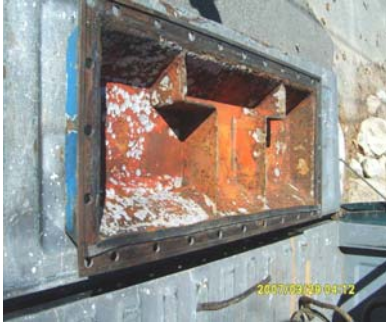
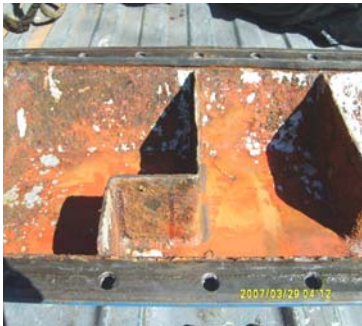
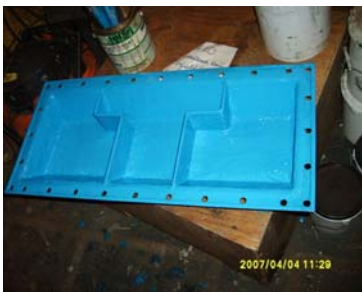
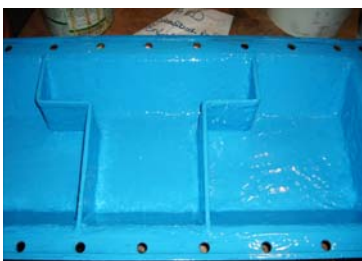
Division bars on heat exchanger cover were corroded.

Customer experiencing leakage where the division plate bars had corroded.

Pumpcoat grit blasted the cover and repair welded the division bars. Piece was then epoxy coated for corrosion resistance.
