PUMPCOAT

CASE HISTORY 034 - COOLING TOWER REPAIR

Boston hotel had severe leakage and corrosion of cooling tower.

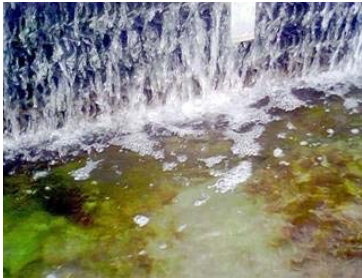
Basin corrosion

It was found that the cooling tower basin had failed. It had rusted and eroded after constant exposure to water and the environment, and was now leaking badly

Pumpcoat mobilized to site. Cooling tower was taken apart. Replacement fill was installed due to the old fill being cracked and falling apart. New sheet metal basins were fabricated at an affiliate machine shop. The basins were then coated with corrosion resistant epoxy coating. Special attention & coating was given to those structural areas that also had corrosion damage on the cooling tower. The cooling tower was reassembled. The repair that Pumpcoat did considerably extended the life of the cooling tower at a fraction of the cost of a new tower, resulting in a significant savings to the customer.
