# PUMPCOAT

### CASE HISTORY 005 - DEMIN TANK LINING

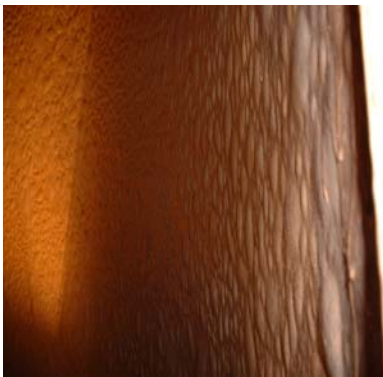
Power plant in New England needed to replace tank lining on demin tank which was 12 years old.

Coating had bubbled but not failed.

After grit blast, it was found that excessive pitting on the tank bottom had occurred, and a polyester reinforced rebuild system was employed to restore tank integrity.

Our coating specialists and a local sand blaster were employed to reline the tank.

Work was accomplished in 7 days during an outage.
