PUMPCOAT

CASE HISTORY 022 - HIGH FLOW PUMP

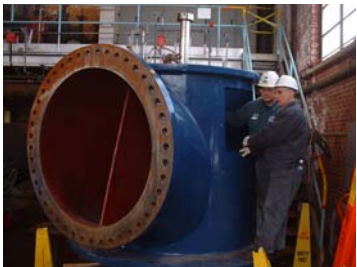
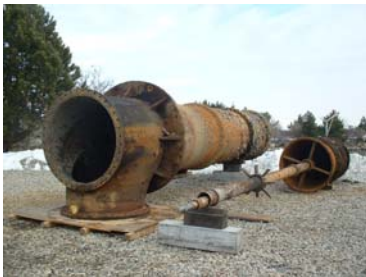
Customer needed replacement salt water pump.

Customer salt water pump was 40 years old.
Customer decided to order a new pump which would fit into existing pump location.

Pumpcoat worked with Ruhrpumpen to design a 316 SS pump with 2 % Nickel cast iron head which bolted in and duplicated existing pump hydraulics.
The new pump was designed so that the Nitronics 50 line shaft couplings were interchangeable with the customers existing pumps to reduce inventory.
