PUMPCOAT

CASE HISTORY 029 - ABRASION RESISTANT THERMOWELL

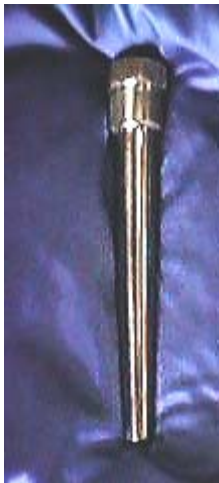
Coal burning Power Plant in Massachusetts going through a lot of thermowells due to abrasive nature of application.

Customer having to switch out Thermowells in their ash system every 3 months as the metal would wear out on the lower end.

Pumpcoat engineered a thermowell that was angled instead of round to reduce direct impact from ash flow. It was milled at an affiliate machine shop, and then spray coated with specialty coating to resist wear of 1350 degrees F ash. This newly designed thermowell has an estimated life of 9 months—1.5 years, resulting in a significant cost savings to the customer.
