PUMPCOAT

CASE HISTORY 030 - SPECIALTY COATED ASH VALVE SEATS

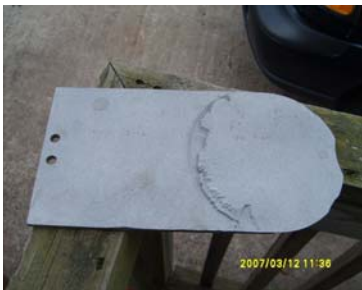
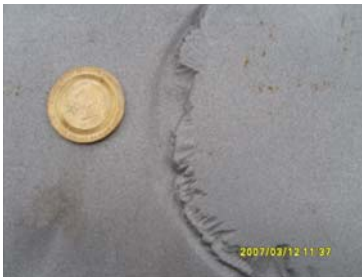
Coal burning Power Plant in Massachusetts finding high wear rate of Ash Valve seats due to corrosive nature of Ash.

Customer losing time & expense in having to switch out their ash valves knife gates frequently as ash wore them down. The OEM products were lasting only about 5-7 months before wearing out..

Pumpcoat engineered a process for reusing the knife gates by grinding the surface and application of a specialty coating that would better withstand the corrosion & abrasion.. This has extended the life of the parts to a few years, providing the customer with significant cost savings in time and materials.
