# PUMPCOAT

### CASE HISTORY 033 - EPOXY COATED & CUSTOM PUMP BASES

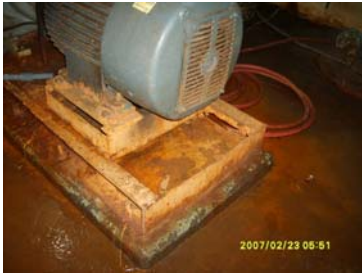
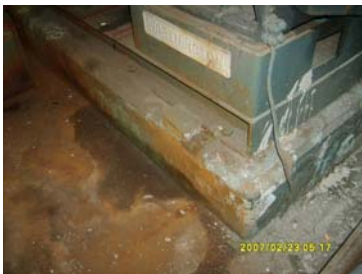
Trash burning power plant had excessive corrosion on several pump bases.

Customer had fish pumps in salt water service. The pump bases had suffered corrosion & oxidation.

Pumpcoat mobilized to customers site to blast, repair damage, and epoxy coat the pump bases. This repaired & prevented further damage and the coating offered extra wear resistance for the future. In cases of extreme damage or an existing base, Pumpcoat also has the capability of custom manufacturing pump bases to specifications.
